A METHOD FOR DETECTING STRUCTURAL  
DETERIORATION IN BRIDGES

H. A. Cole, Jr. and R. E. Reed, Jr.

NEAR TR 71

July 1974

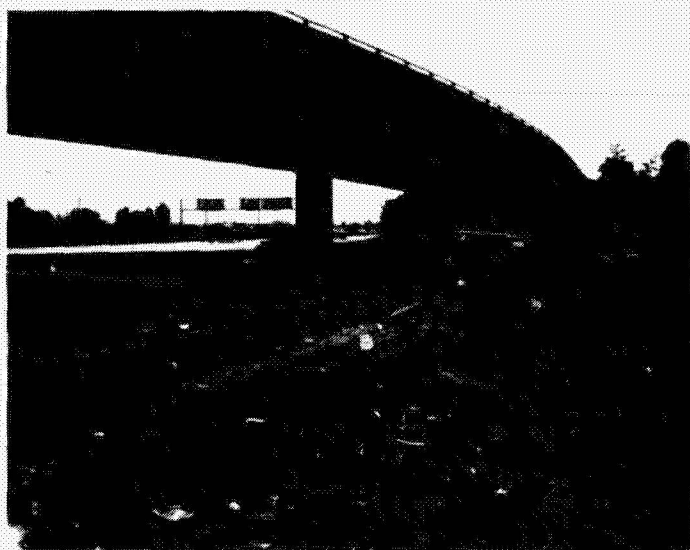
Figure 3.- 101-85 Separation, looking  
north on Highway 101.

A typical highway girder bridge was instrumented in the field to determine if the magnitude and frequency of the vibrations were sufficient for analysis and to determine if standard signatures were subject to change due to effects other than cracking, such as environmental variations. With permission of the California State Division of Highways, one girder of a 5-span bridge located at the intersection of Highway 85 and 101, see figure 3, was instrumented with accelerometers and monitored periodically for a year. Figure 4 shows the span selected. One interior girder of the four comprising the span as well as a diaphragm was instrumented as shown in figure 4 and described in Table I. The span of the welded girder is 17 meters and its depth 2.28 meters. It is of noncomposite design and fabricated of A36 steel.
